# Materials for Oxygenated Wastewater Treatment Plant Construction

July 1978

TECHNICAL REPORT DATA (Please read Instructions on the reverse before completing)			
1. REPORT NO. EPA-600/2-78-136		3. RECIPIENT'S ACCESSION NO.	
4. TITLE AND SUBTITLE MATERIALS FOR OXYGENATED WASTEWATER TREATMENT PLANT CONSTRUCTION		5. REPORT DATE July 1978 (Issuing Date)

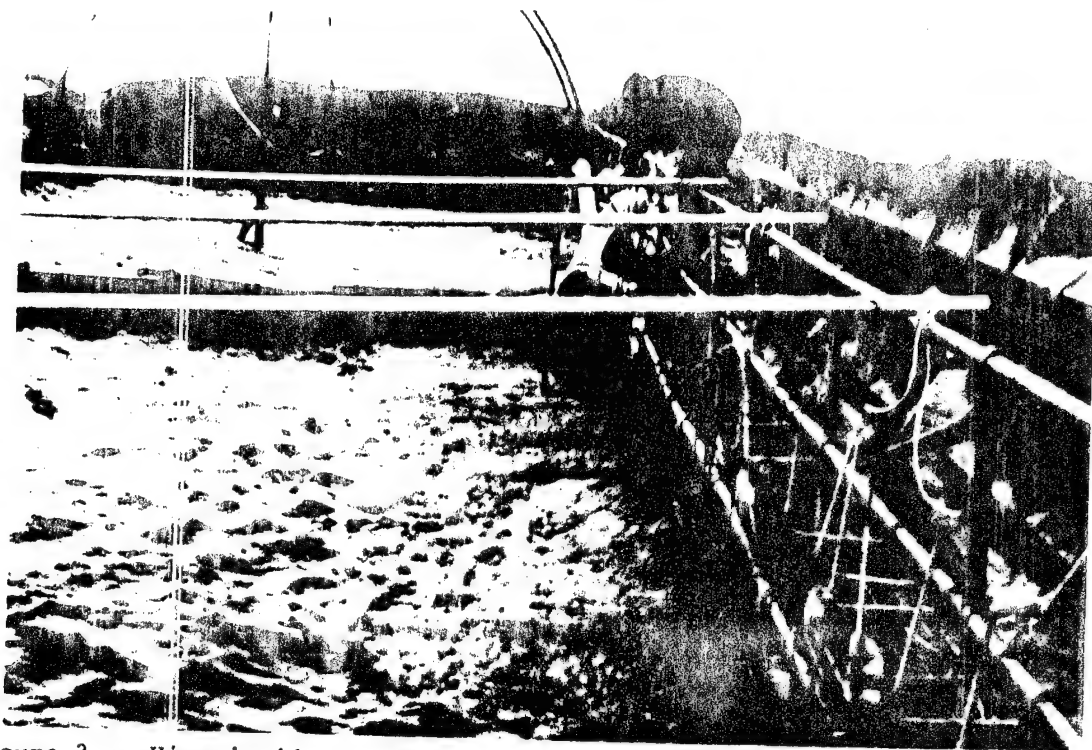
Figure 3. View inside the tent at site 1. Concrete cylinders exposed in the gas phase can be seen (right foreground) along the downstream end of the tank.

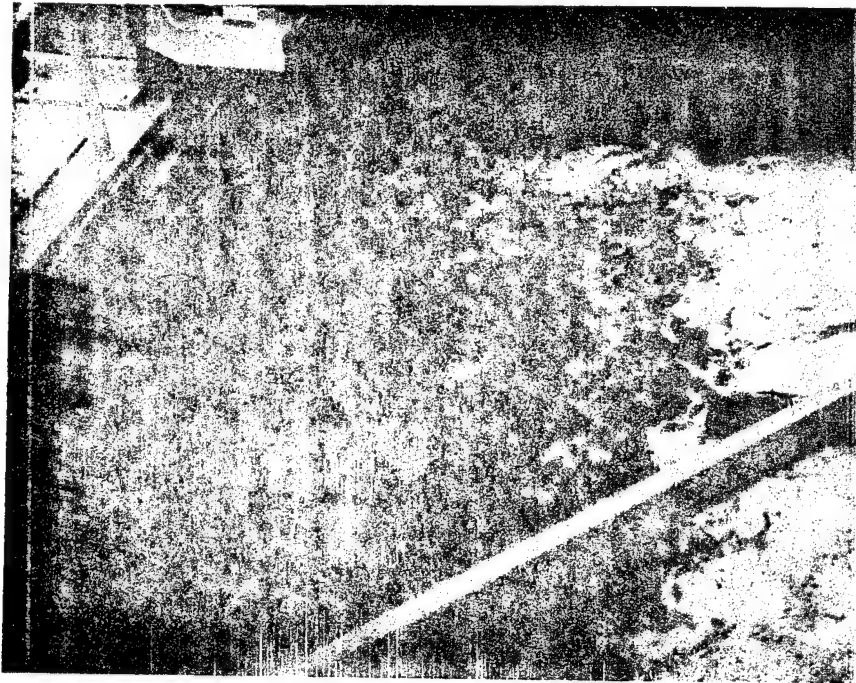
Figure 6. View of site 3 tank with cover removed to show splashing caused by the surface impeller. Test specimens were exposed to this splash zone effect.

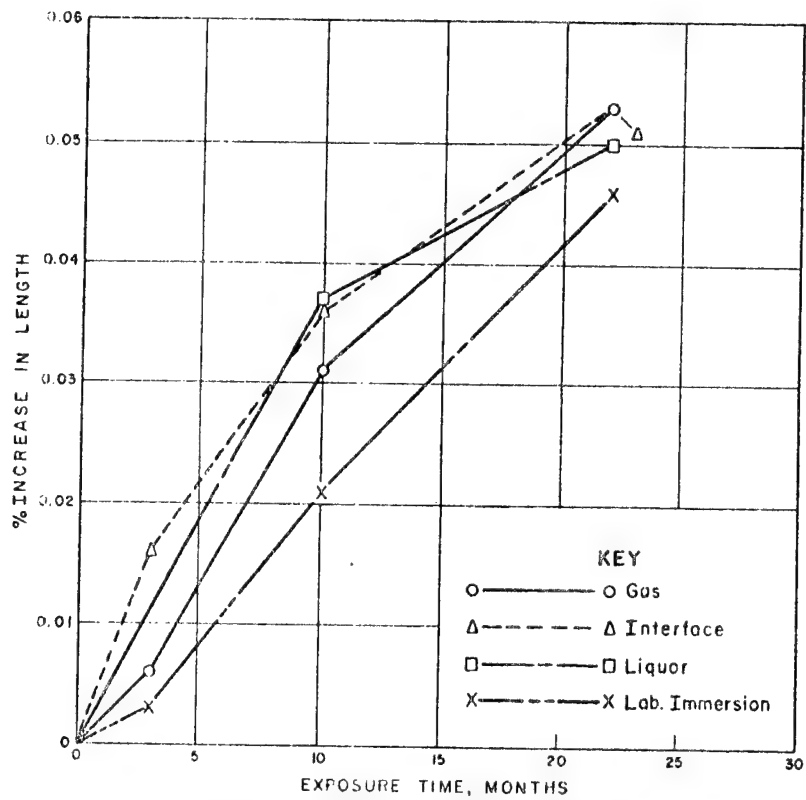
b. The effect of site exposures and laboratory immersion on the lengths of the PIC specimens are shown in figures 12, 13, and 14. The specimens continue to increase in length with duration of exposure. Although much less water is absorbed by the PIC specimens than the two conventional concretes, their increase in length after 22 and 28 months of exposure is of the same order of magnitude as the conventional concretes.

FIGURE 12. EFFECT OF SITE I EXPOSURE AND LABORATORY IMMERSION EXPOSURE ON LENGTH OF POLYMER IMPREGNATED CONCRETE

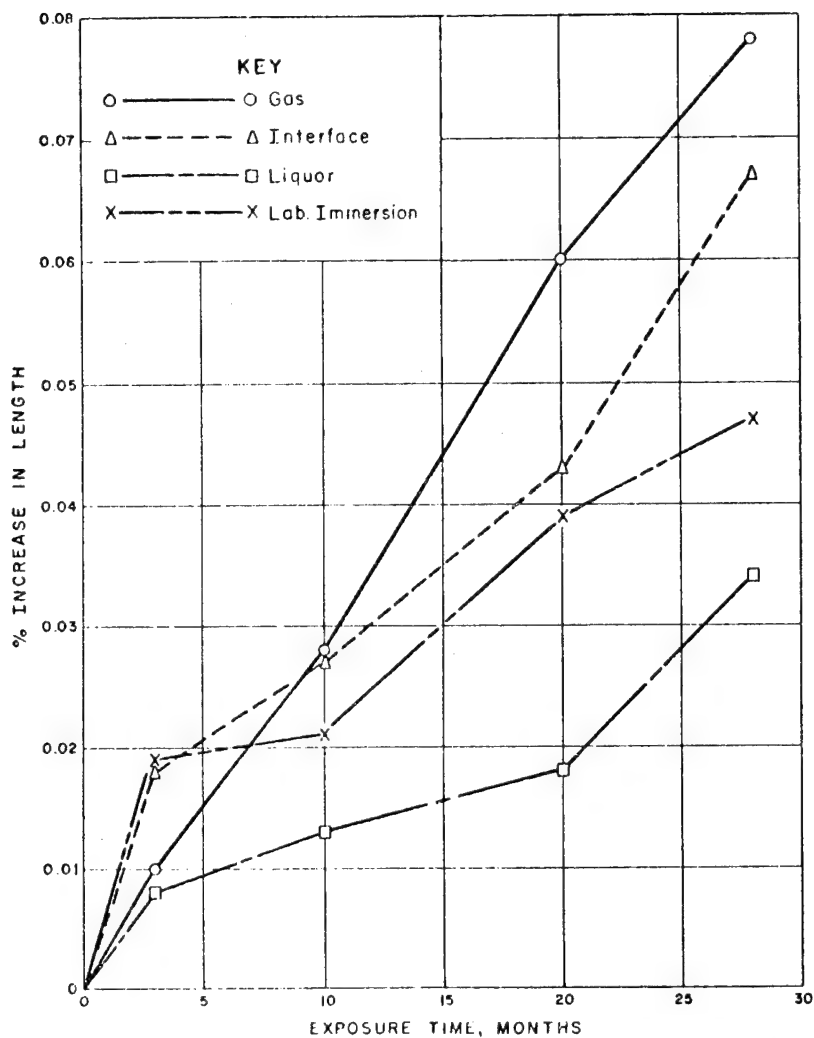
FIGURE 13. EFFECT OF SITE 2 EXPOSURES AND LABORATORY IMMERSION ON LENGTH OF POLYMER IMPREGNATED CONCRETE

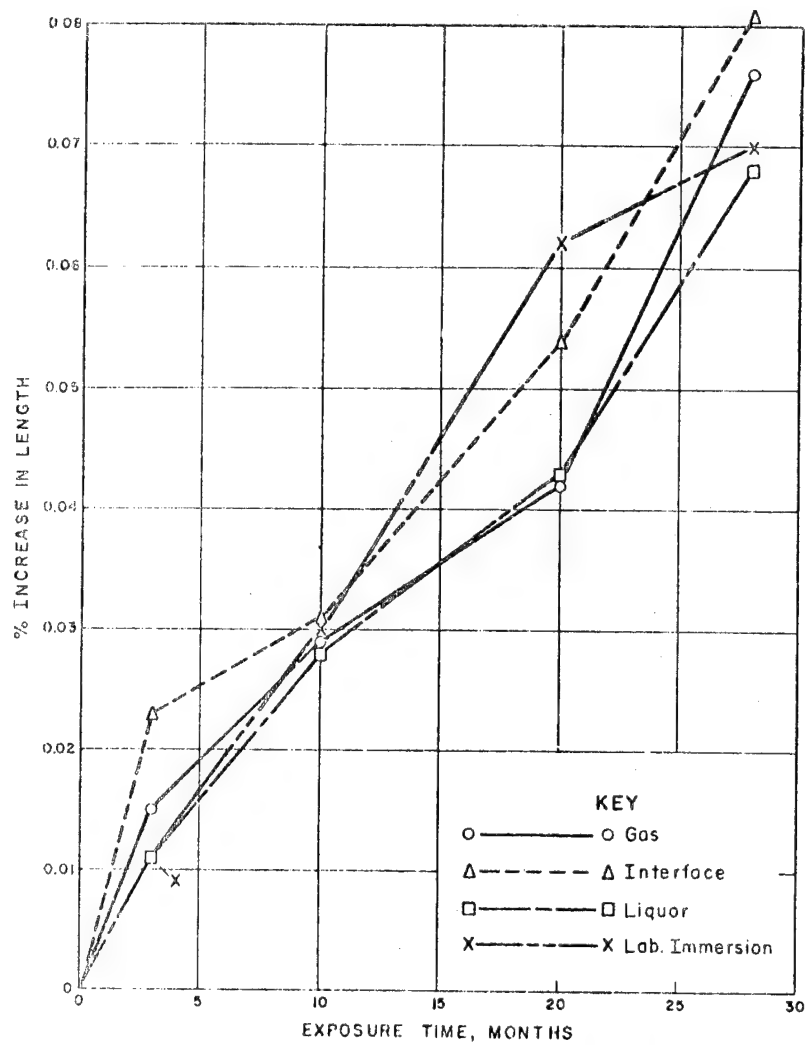
FIGURE 14 EFFECT OF SITE 3 EXPOSURES AND LABORATORY IMMERSION EXPOSURE ON LENGTH OF POLYMER IMPREGNATED CONCRETE
